# Experimental Investigation on Reducing the Quality Concern of Blow-Hole In Cylinder Block

**Abstract:-** In this research paper an Automotive component having Blow-hole defect has been taken. The said component is an Automotive 3-Cylinder engine block with displacement of 799cc. since it is the important component it has to be of the higher quality so there is no room for shortcuts. In this paper various analysis of part is done using Quality Control tools (QC Story). In order to be efficient and effective we follow Plan-Do-Check-act (PDCA) cycle for identifying the optimum process parameter in order to improve the casting quality and reduce the rejection rate at factory end. From the Pareto chart and Cause & Effect diagram, the major causes are prioritized and controllable factors identified.

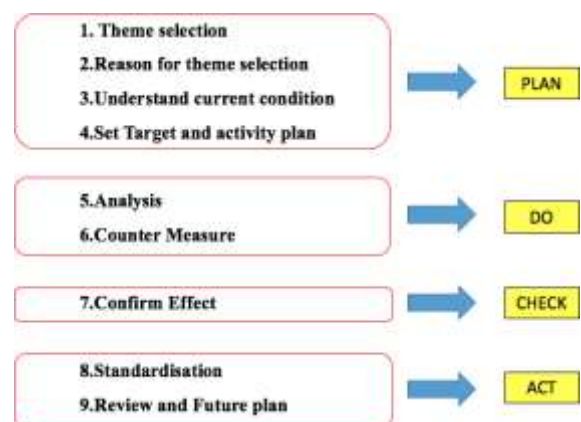
QC Story is a methodology in Total quality management (TQM), which is intended to solve a problem. QC Story is based on the principle of Plan-DO-Check-Act (PDCA). Generally, a Qc Story is a 7 steps procedure, but elaborated to 9 steps for better efficiency.

Fig 2: QC Story procedure.

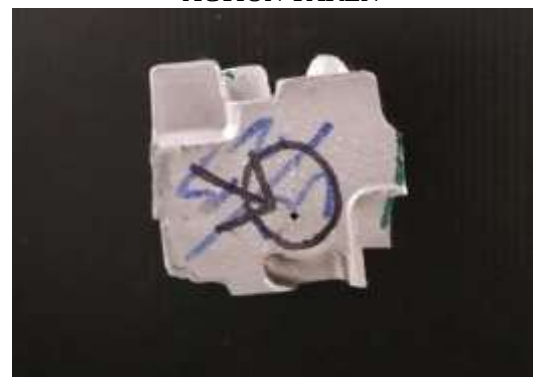
Fig 6: Blow-hole defect cut piece.

As shown in the above fig 6, the blow-hole was found at the gate area location on the Cylinder block casting. G1 and G4 gate location was found Significant and the root cause of the problem was identified.

The corrective action was taken in the die since the cooling is insufficient at defect location. The temperature at G1 and G4 was high and it corrected by increasing the depth of cooling points in the die.
